ASSESSMENT AND REPRESENTATION OF SPATIAL CHANGES OF AQUATIC VEGETATION DISTRIBUTION IN THE DANUBE DELTA.

CASE STUDY: BABINA, CORCIUVATE AND CIORTIC LAKES – MATIȚA-MERHEI AQUATIC COMPLEX

GABRIEL IORDACHE^{1,2}, MARIAN MALAGEANU¹

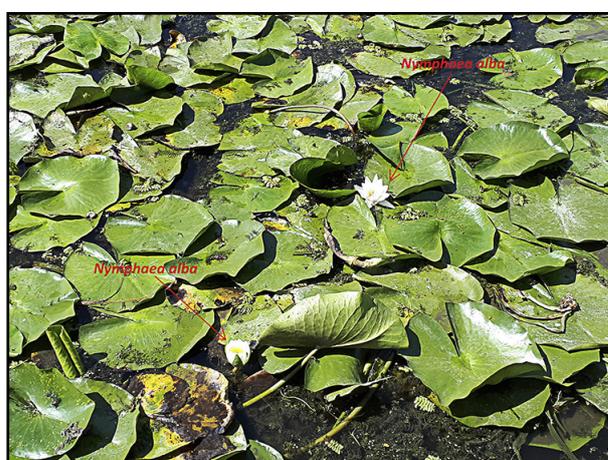
Fig. 6. Areas with *Nymphaea alba* (detail).

Several species of aquatic plants have been identified on the free water surface of the studied lakes: *Trapa natans* (water chestnut) (Fig. 3), *Salvinia natans* (floating fern), *Stratiotes aloides* (water soldier) (Fig. 4), *Phragmites australis* (common reed), *Nuphar lutea* (yellow water-lily) (Fig. 5) and *Nymphaea alba* (white water-lily) (Fig. 6).
